## **PowerWorx Front Access Fuse Panel Replacement**

TFC-WORX-FAM1 PowerWorx Front Access Fuse Panel Replacement

(Equiv. to ADC # TFA-FAM) (used in Remote Cabinet Sites)

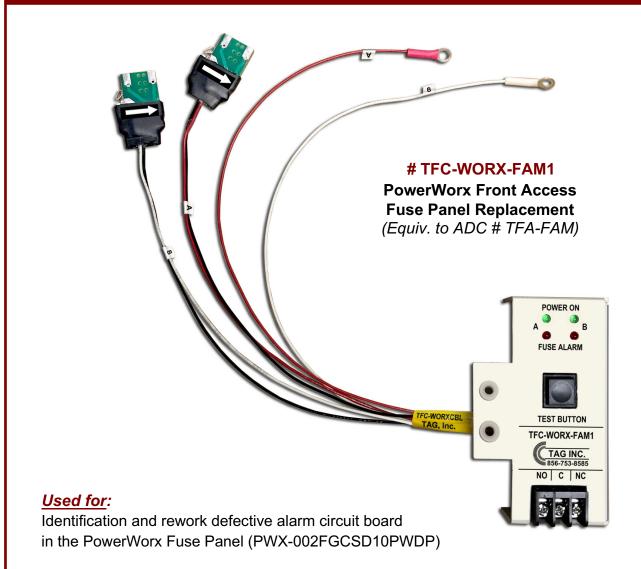
Defective Alarm Circuit Board in the PowerWorx Fuse Panel incorrectly sets remote power alarm. Alarm contact closure has a dead short across normally open and common contacts indicating power distribution or power bus trouble. This problem only affects the ability to monitor local or remote alarms in the ADC PowerWorx distribution panel.
